PORTSMOUTH CIVIC CENTER

Final Submittal

**PACE Project #19050
April 17, 2019**

CONDITION ASSESSMENT

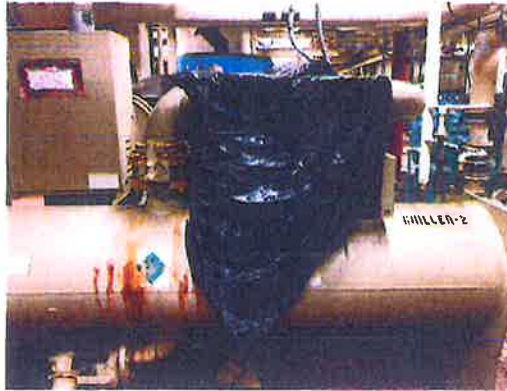
At the time of the visit the chiller was not operational. Oil pressure alarm was on the chiller control screen. The chiller has reached its expected service life of 25 years.

Chiller appears to be in poor condition.

Have the chiller serviced and repaired. Plans should be made to replace the chiller in the near future.

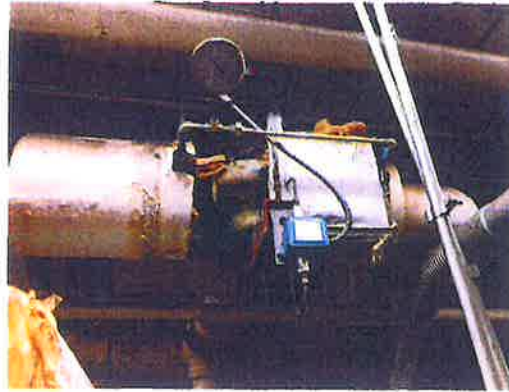
Primary chilled water pump above C-2 appears to be in poor shape. Visible leaks, uninsulated and corroded.

Chiller 2 circulating pumps (located directly above the chiller)

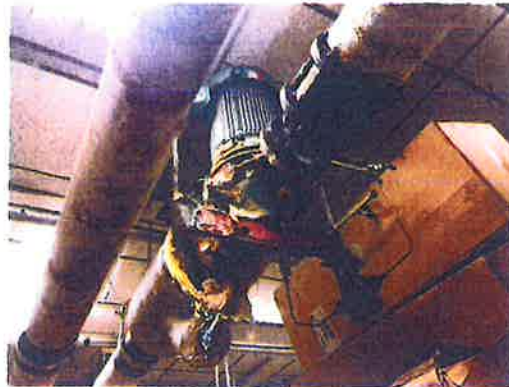
Dual Temperature pump serving the jail motor has bad bearings (very noisy operation), is very badly corroded and has visible leaks.

Pump serving the Jail building

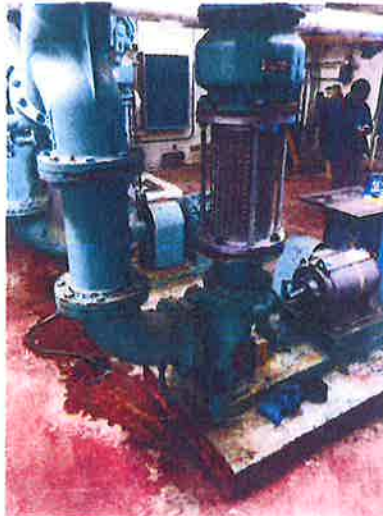
Hot water pumps, both show signs of leaks and corrosion. Exact age is not known but they appear to be over 20 years old. Expected service life for this type of equipment is 20 years. One of the pumps (P-1) was disassembled during the site visit. Both pumps are in poor condition and should be replaced.

Disassembled Pump P-1

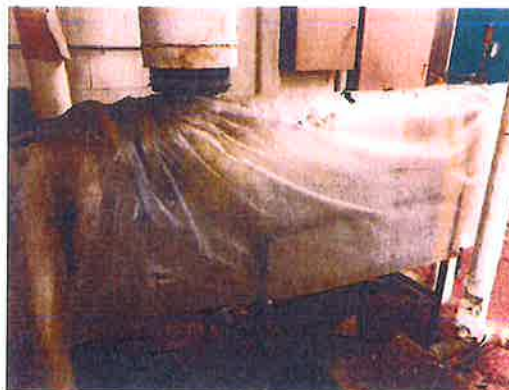
Domestic hot water heat exchanger is covered with plastic to protect it from water leaks through building expansion joints. It appears to be operational but not in a good condition. Recommend eliminating it once it fails, and installing a new domestic hot water heating system, which would also eliminate the need to run a very large heating hot boiler in the summer to provide domestic hot water.

Domestic hot water heat exchanger

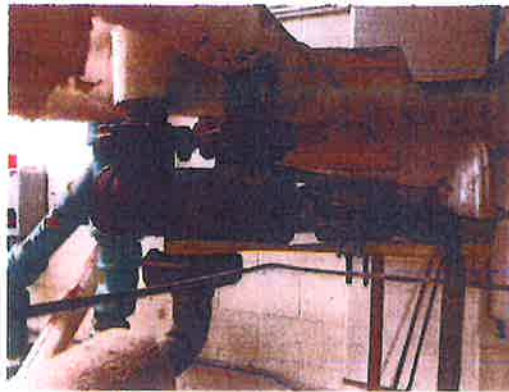
Dual temperature switch over valves do not function and the switch over from heating to cooling needs to be done manually. The valve non-functioning pneumatic actuator is being held together by a strap. When the system is switched over, according to maintenance personnel, it causes relief valves to open due to differential in two system pressures.

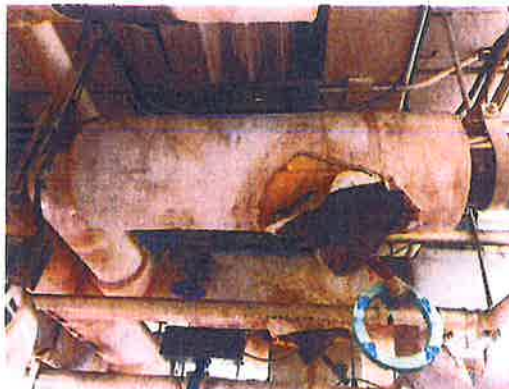
Original isolation valves that are still in place are badly rusted and the handles tend to break off when operation is attempted.

Other piping accessories that have not been recently replaced are severely corroded, indicating elevated moisture, and humidity levels in the mechanical room.

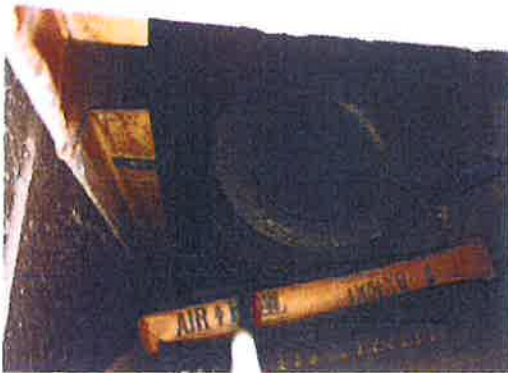
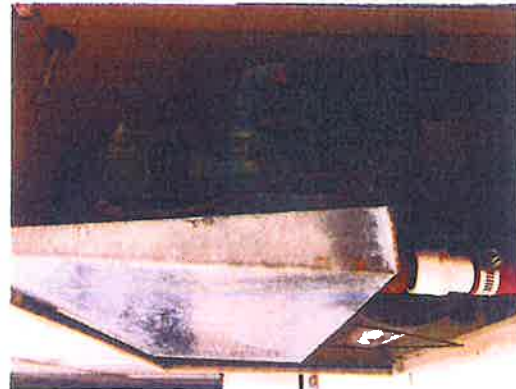
Fan coils in the basement appear to be original to building construction and are in bad shape. Most do not function and are in disrepair. Filters are dirty and have not been replaced in some time, control valves are not functioning, and some of the access panels are missing.

Basement Fancoil Units

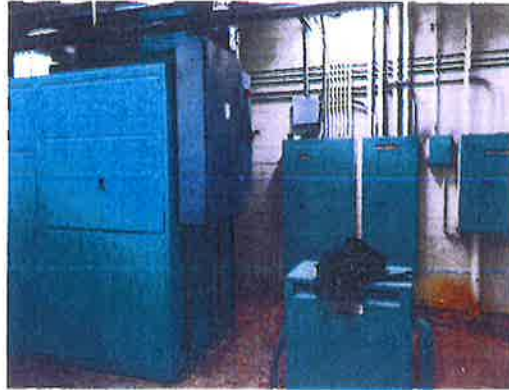
There are additional fusible switches tapped off the bus for additional feeders because of obsolete switchboard and no available space for additional breakers.

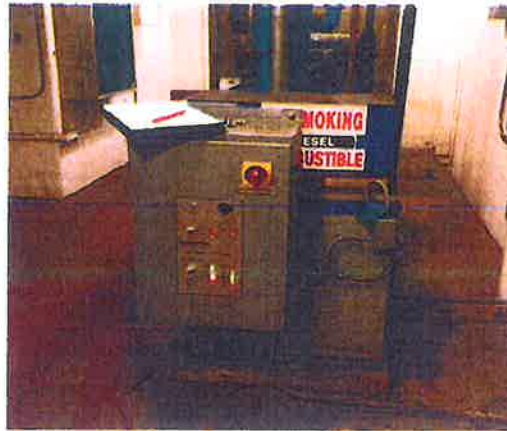
Each generator has its own day tank with associated simplex fuel supply pump and supply piping. There is no return piping or return pump.

The fuel system to the day tank does not have a return line and return pump to keep the day tank from overflowing in the event that the supply pump did not shut off when called for as recommended by NFPA 31.

We also recommend that the day tanks be replaced with a duplex pump arrangement so that it has a supply pump and a return pump as required by the NFPA 31.

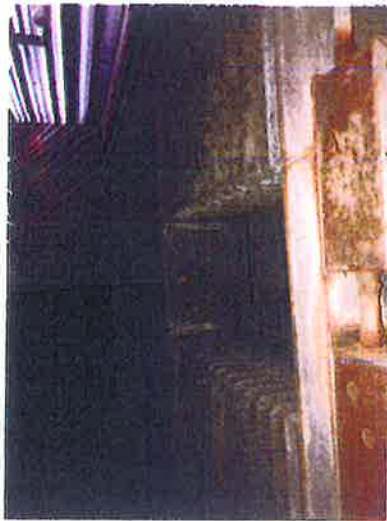
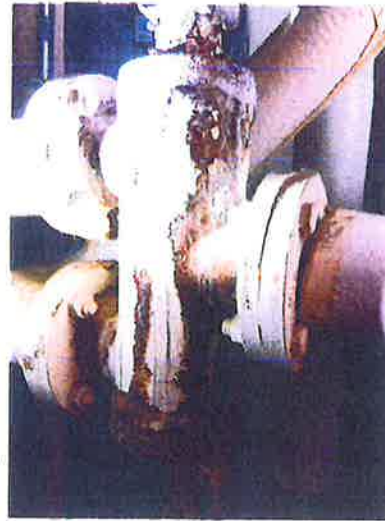
Unit is utilizing an electrostatic filter system, which does not appear to be functional, has missing filter modules from the rack, loose belts on the fans, debris built up on the coil, control valve does not modulate and leaks, coil is not accessible for proper cleaning or service.

Unit should be replaced with a more traditional and standard air handling unit.

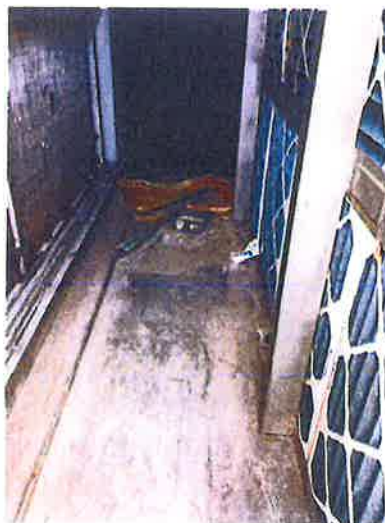
Very poor access to filter section. Filters need to be replaced. There is debris within the unit cabinet, fan belt is loose, drain pan is severely rusted, condensate drain line is broken, visible leak in the hot water heating line.

Debris in unit cabinet.

Unit should be serviced, cleaned and repaired. With proper maintenance, the unit should have another 5 years of service left.

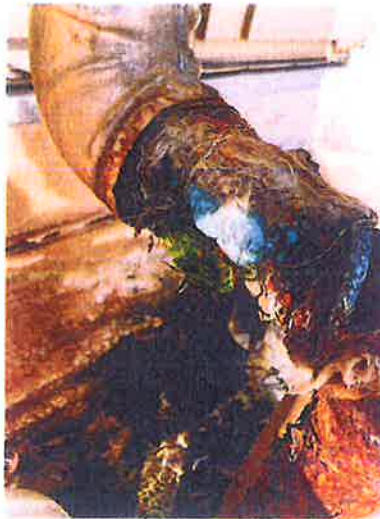
Water leak through a split shut off valve.

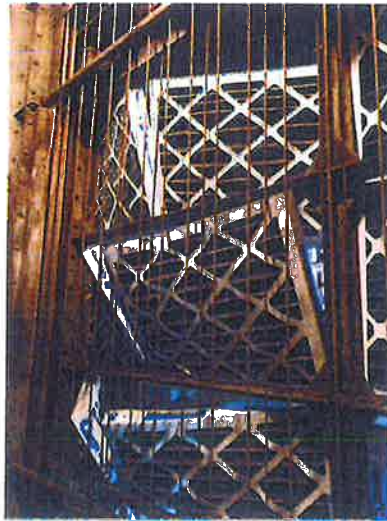
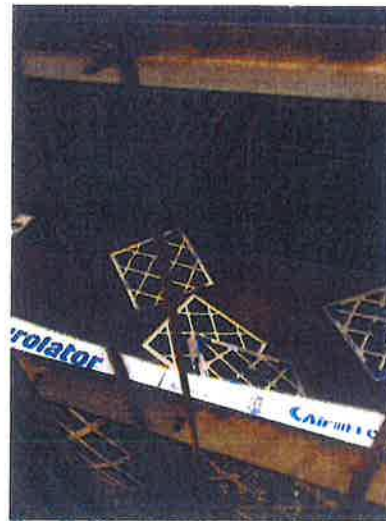
Unit used to utilize an electrostatic filter system, which has been disconnected and regular pleated filters are being used. Multiple filters are out of the tracks, some have been pulled out of the track by airflow due to debris built up. Unit has loose belts on the fans, debris built up on the coil, control valve does not modulate and leaks, coil is not accessible for proper cleaning or service.

Filters out of track

Unit should be replaced with a more traditional and standard air handling unit.

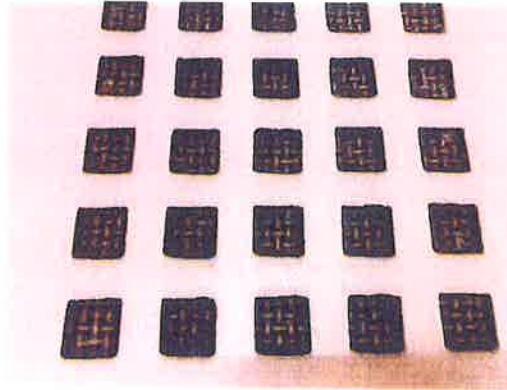
EF-1 was operational but is in poor shape due to age of equipment. It has surpassed it's service life and plans should be made to replace it in the near future. EF-2 has been replaced and is only 5 years old, with proper maintenance it should last another 15 years. Exhaust ductwork and grilles appear dirty and should be cleaned. Exhaust grilles have been painted multiple times over the years which caused a reduction in the open areas of the grilles, which are also clogged up with dust and debris affecting their performance.

Clogged Exhaust Grilles

Based on the condition and age of EF-1, we recommend replacing the fan. Exhaust ductwork should be cleaned and the exhaust grilles should be replaced.

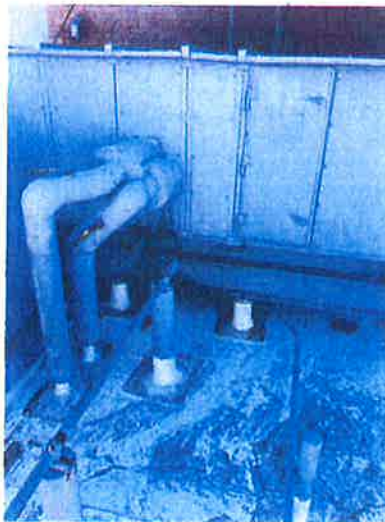
Make-up air is provided by two roof mounted units. Age of the equipment could not be determined due to missing name tags, but they appear to be original to the installation. They appear to be functioning but are in poor shape due to age and exposure to the elements.

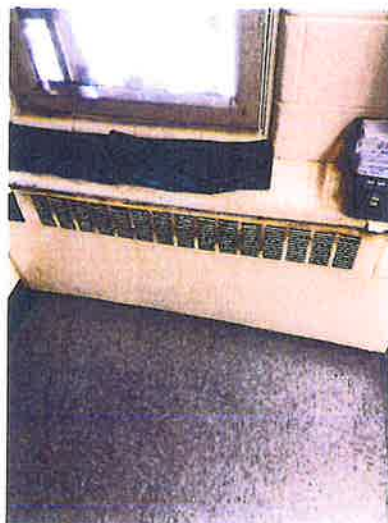
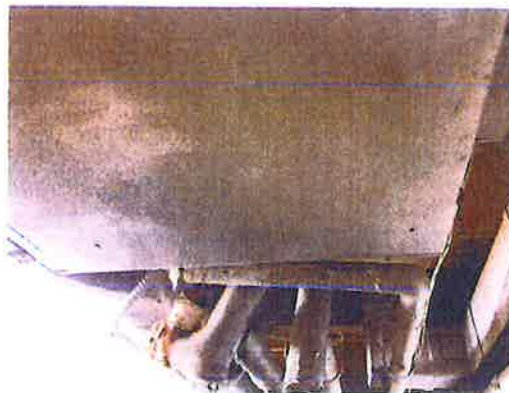
Fan coils appear to be in poor shape. According to maintenance the 3-way control valves are non-functioning, so units operate on/off instead of modulating. Coil piping accessories are in poor condition.

Fan Coil Units.

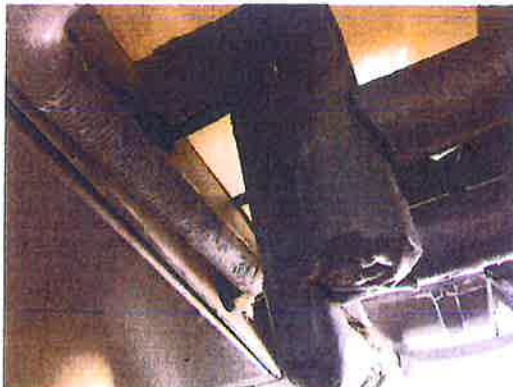
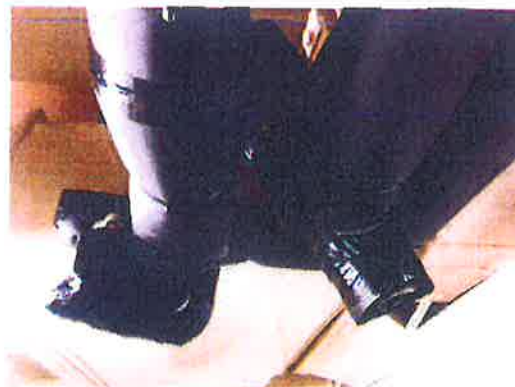
Piping within the building is original and is over 40 years old. Insulation is starting to fail, reducing the efficiency of the system. Some insulation has been patched and reinsulated, but improperly over top of original insulation.
